Facility Name: <u>Quintec, Inc.</u>			
Facility Identification Number: <u>IND 000 199 653</u>			
A.1 General Correspondence <u>A.1.1-A.1.7</u>	1	B.2 Permit Docket (B.1.2)	
A.2 Part A / Interim Status <u>A.2</u>	1	.1 Correspondence <u>B.1.1</u>	1
.1 Correspondence	Y	.2 All Other Permitting Documents (Not Part of the ARA) <u>A.1.2(3), B.1.3, B.1.4, B.1.8</u>	5
.2 Notification and Acknowledgment	Y	C.1 Compliance - (Inspection Reports) <u>C.1.1</u>	1
.3 Part A Application and Amendments	Y	C.2 Compliance/Enforcement <u>C.2.2(2)</u>	2
.4 Financial Insurance (Sudden, Non Sudden)		.1 Land Disposal Restriction Notifications	
.5 Change Under Interim Status Requests		.2 Import/Export Notifications <u>C.2.2</u>	1
.6 Annual and Biennial Reports		C.3 FOIA Exemptions - Non-Releasable Documents <u>C.3.2(2)</u>	2
A.3 Groundwater Monitoring		D.1 Corrective Action/Facility Assessment	
.1 Correspondence		.1 RFA Correspondence

**RE: EPA 2009 Multi-media RCRA Inspection Report
Notice of Violation
Quemetco, Inc., Indianapolis, IND 000 199 653**

Attachment A
Inspection Photographs
Quemetco, Inc. (EPA ID No.: IND000199653)
Indianapolis, Indiana
May 18 – 20, 2009

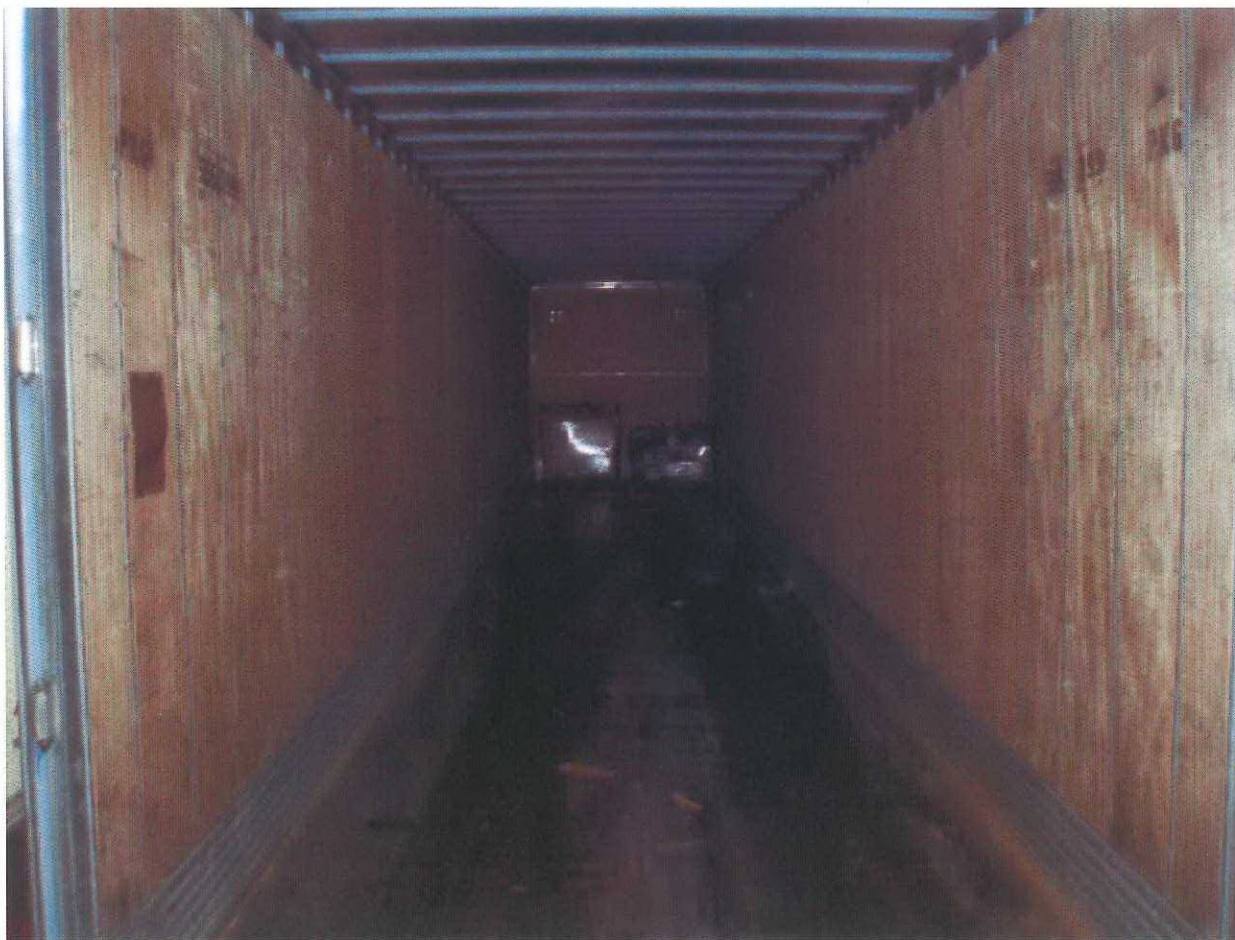
Photograph 19: Trailer of batteries being unloading at the Wrecker Dock at Quemetco, Inc., Indianapolis, Indiana. The digital photograph was collected on May 19, 2009, at approximately 8:27 A.M. (CST). The photographer was Todd Brown, U.S. EPA. The filename is P5190019.

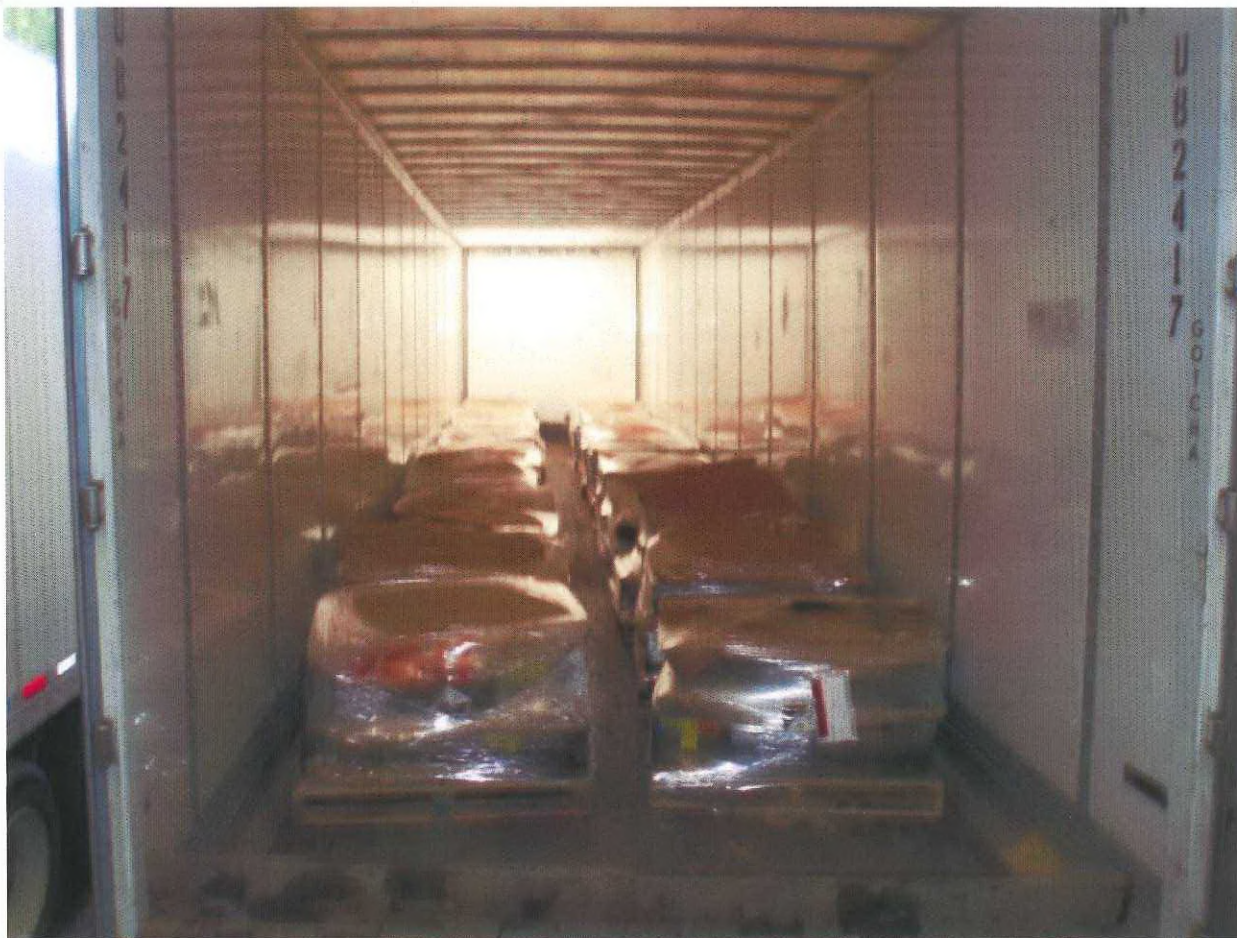
Photograph 20: Trailer of batteries being unloading at the Wrecker Dock at Quemetco, Inc., Indianapolis, Indiana. The digital photograph was collected on May 19, 2009, at approximately 8:27 A.M. (CST). The photographer was Todd Brown, U.S. EPA. The filename is P5190020.

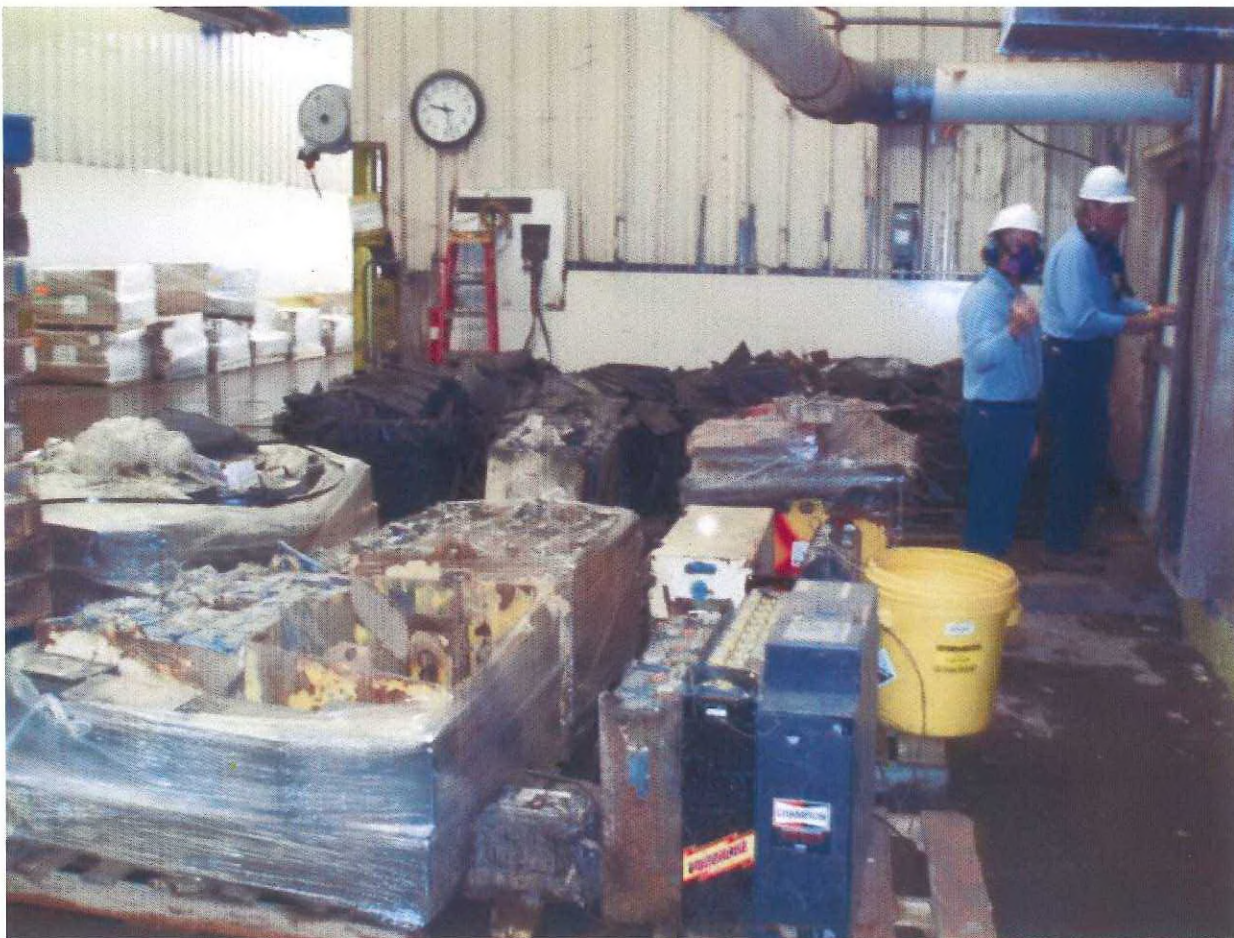
Photograph 21: Batteries and components unloaded at the Wrecker Dock at Quemetco, Inc., Indianapolis, Indiana. The digital photograph was collected on May 19, 2009, at approximately 8:33 A.M. (CST). The photographer was Todd Brown, U.S. EPA. The filename is P5190021.

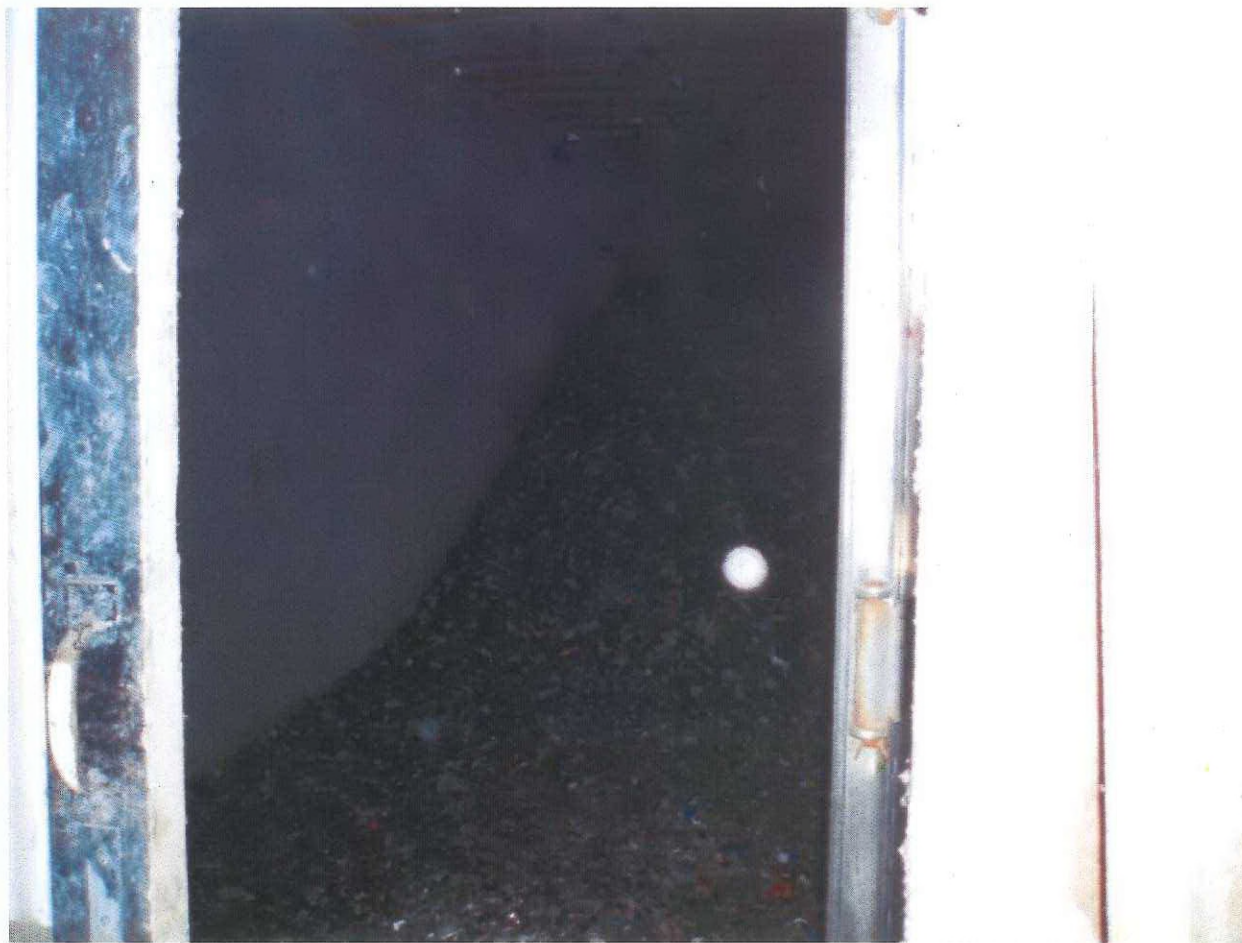
Photograph 22: Ground plastic being blown into a trailer at the Wrecker Dock at Quemetco, Inc., Indianapolis, Indiana. The digital photograph was collected on May 19, 2009, at approximately 8:33 A.M. (CST). The photographer was Todd Brown, U.S. EPA. The filename is P5190022.

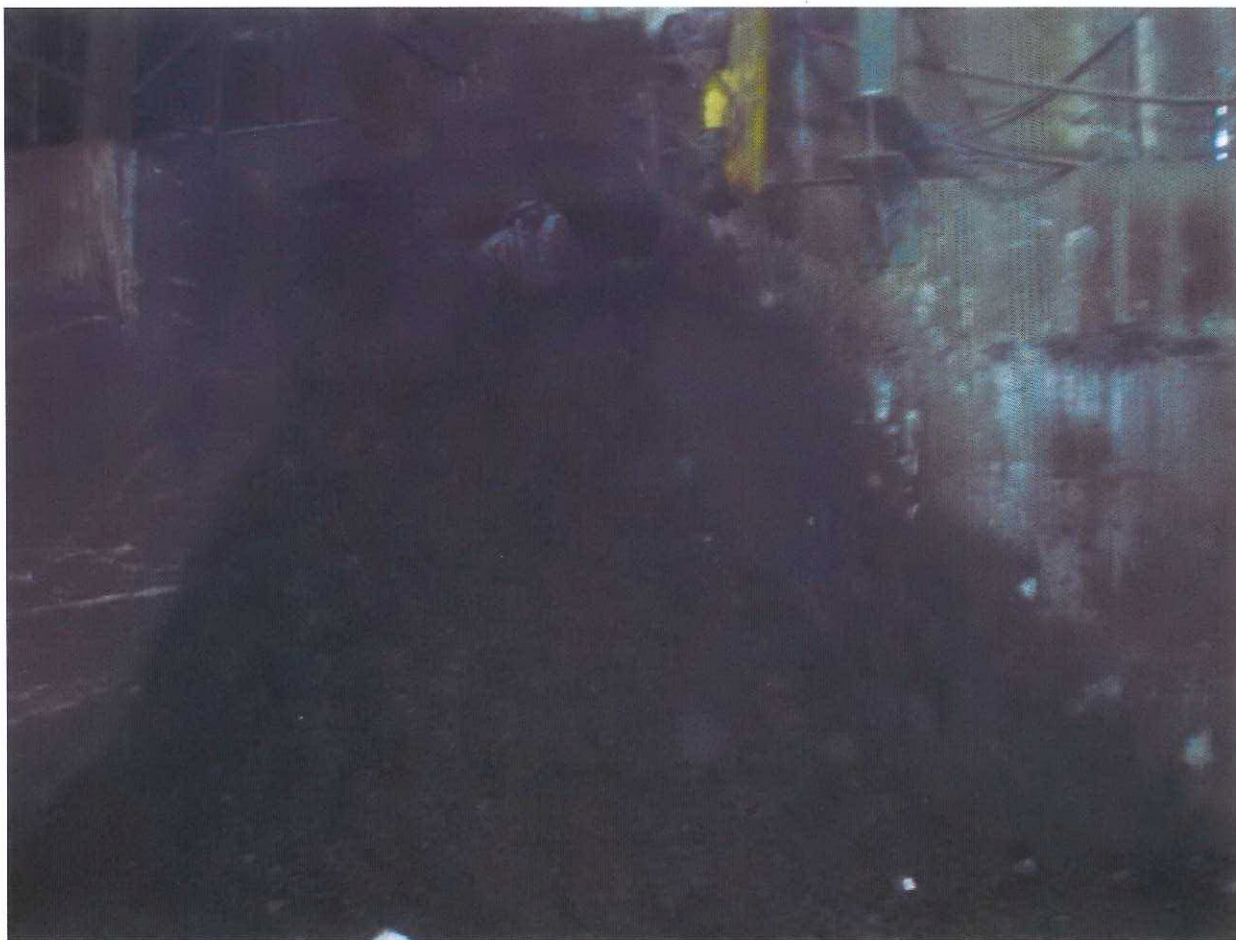
Photograph 24: Pile of ground lead oxide paste and metallic battery components in the Containment Area at Quemetco, Inc., Indianapolis, Indiana. The pile was in the process of being deposited (from the top) when it was photographed. The digital photograph was collected on May 19, 2009, at approximately 8:41 A.M. (CST). The photographer was Todd Brown, U.S. EPA. The filename is P5190024.

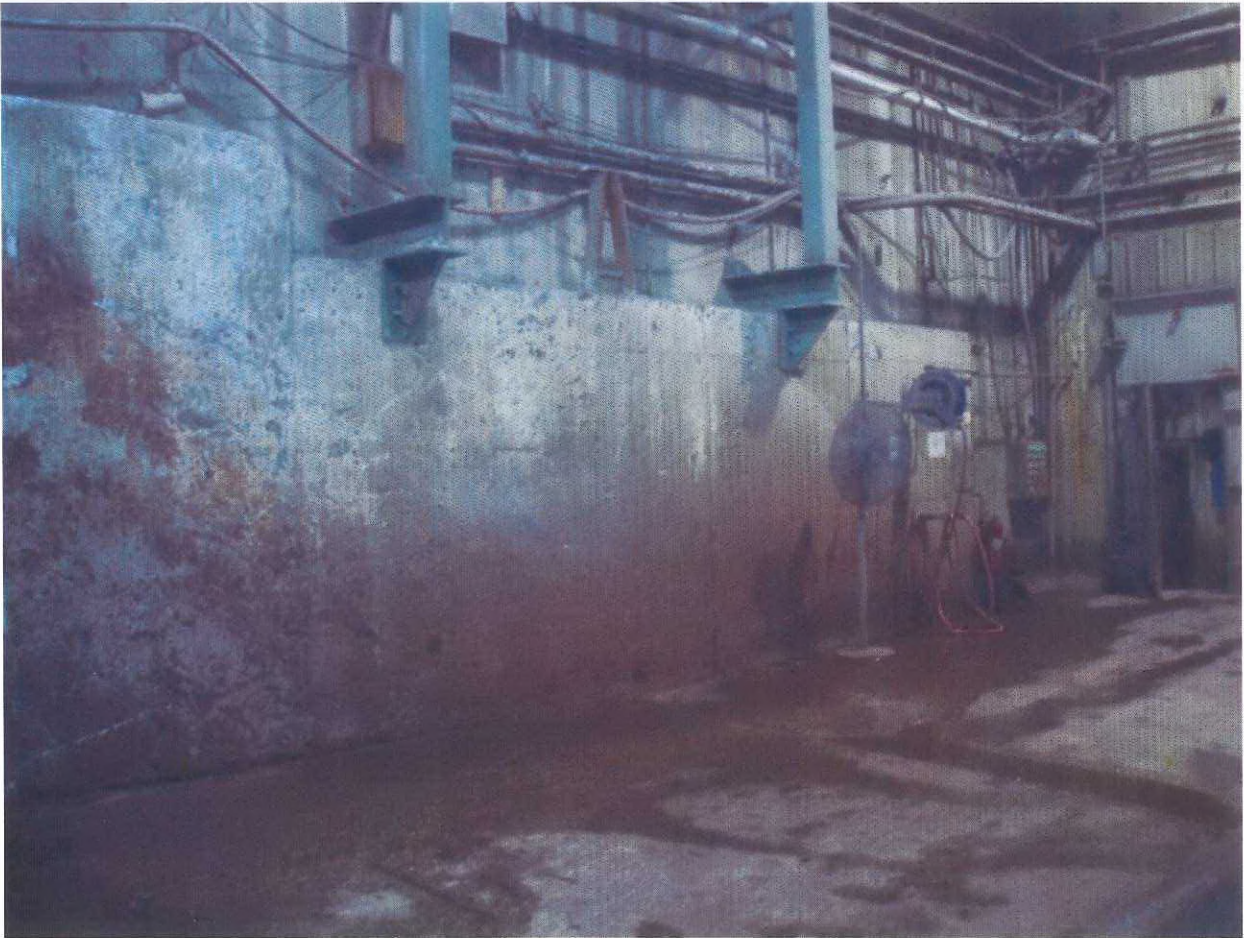
Photograph 25: Containment Area at Quemetco, Inc., Indianapolis, Indiana. The digital photograph was collected on May 19, 2009, at approximately 8:41 A.M. (CST). The photographer was Todd Brown, U.S. EPA. The filename is P5190025.

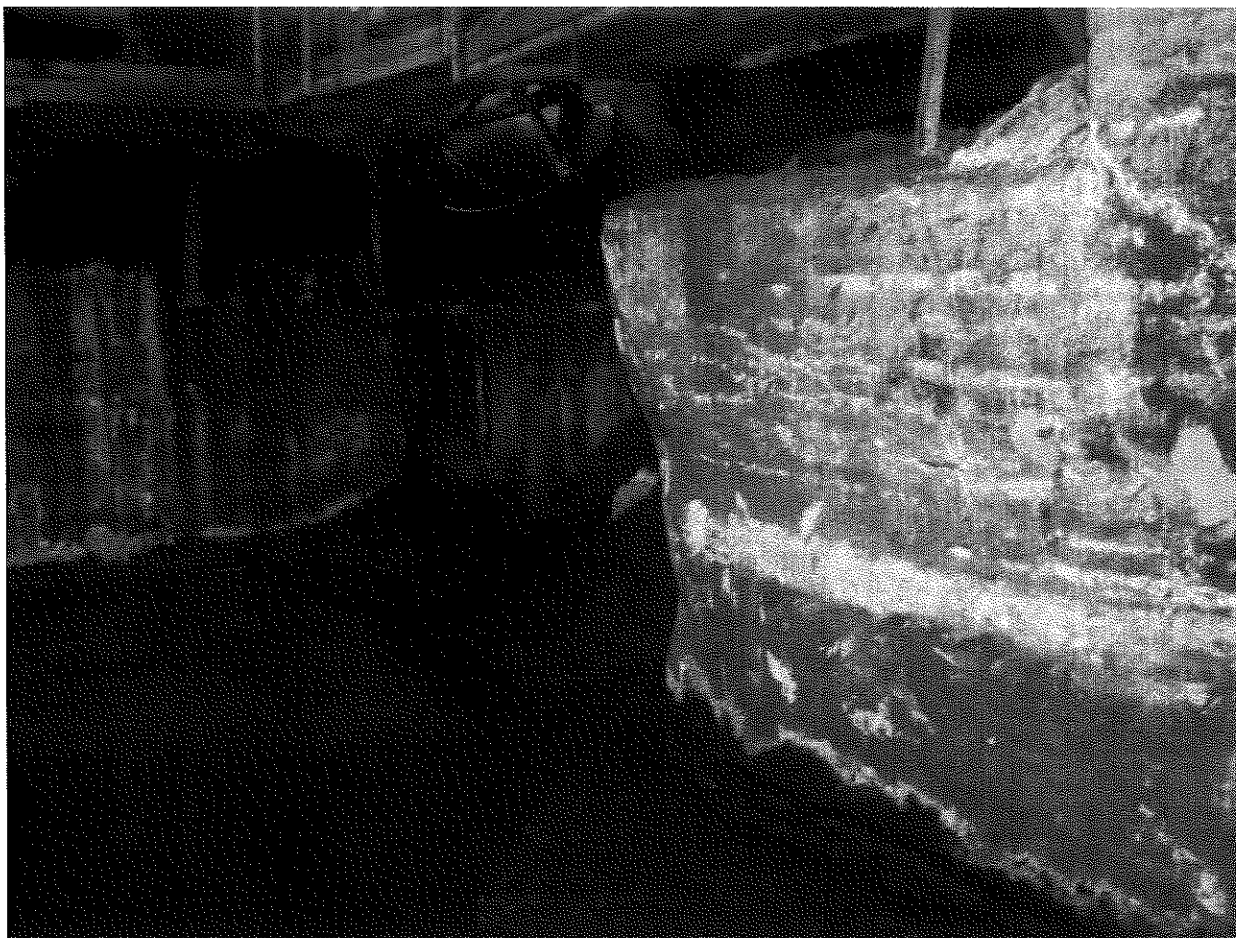
Photograph 26: Containment Area at Quemetco, Inc., Indianapolis, Indiana. The digital photograph was collected on May 19, 2009, at approximately 8:41 A.M. (CST). The photographer was Todd Brown, U.S. EPA. The filename is P5190026.

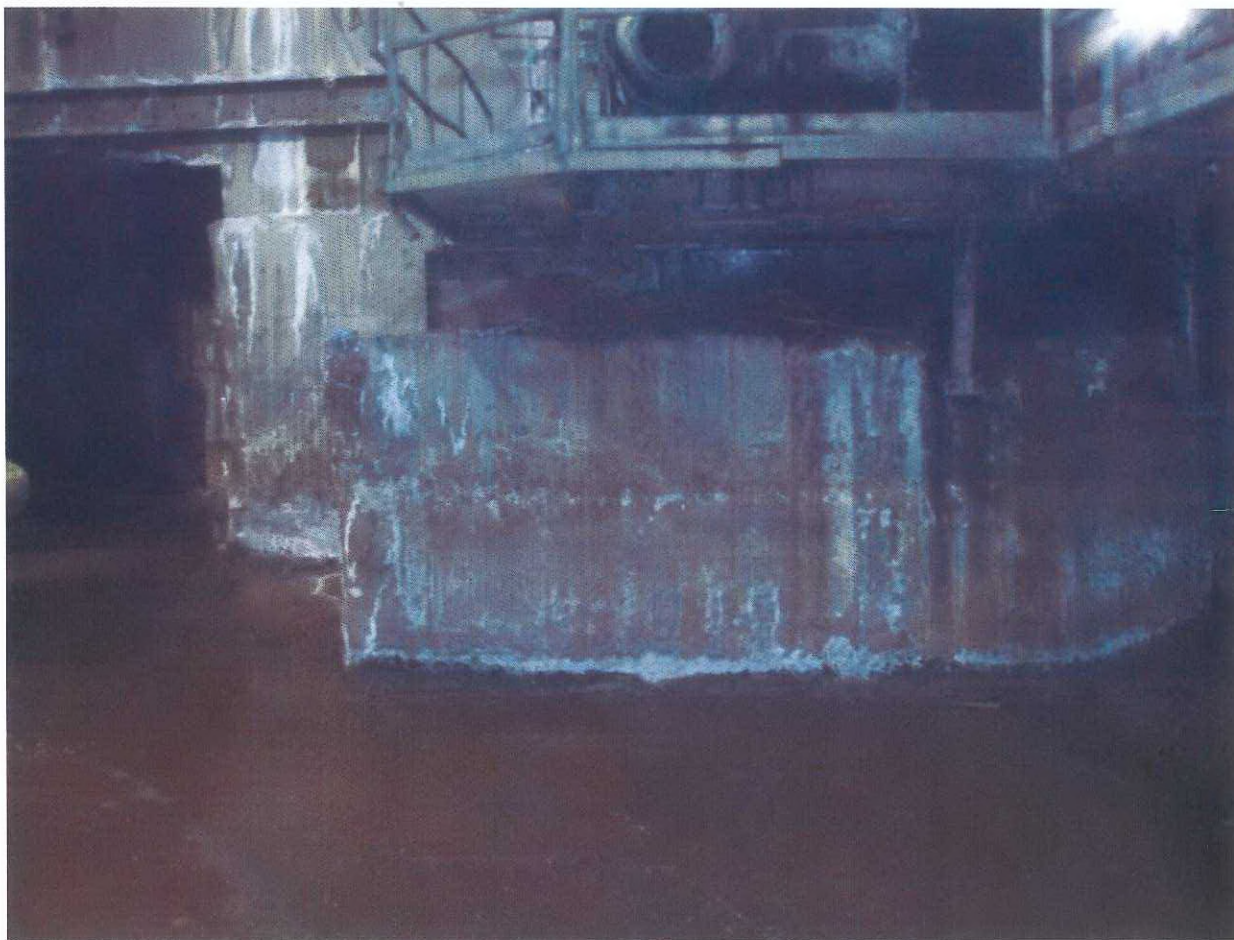
Photograph 27: Containment Area at Quemetco, Inc., Indianapolis, Indiana. The digital photograph was collected on May 19, 2009, at approximately 8:42 A.M. (CST). The photographer was Todd Brown, U.S. EPA. The filename is P5190027.

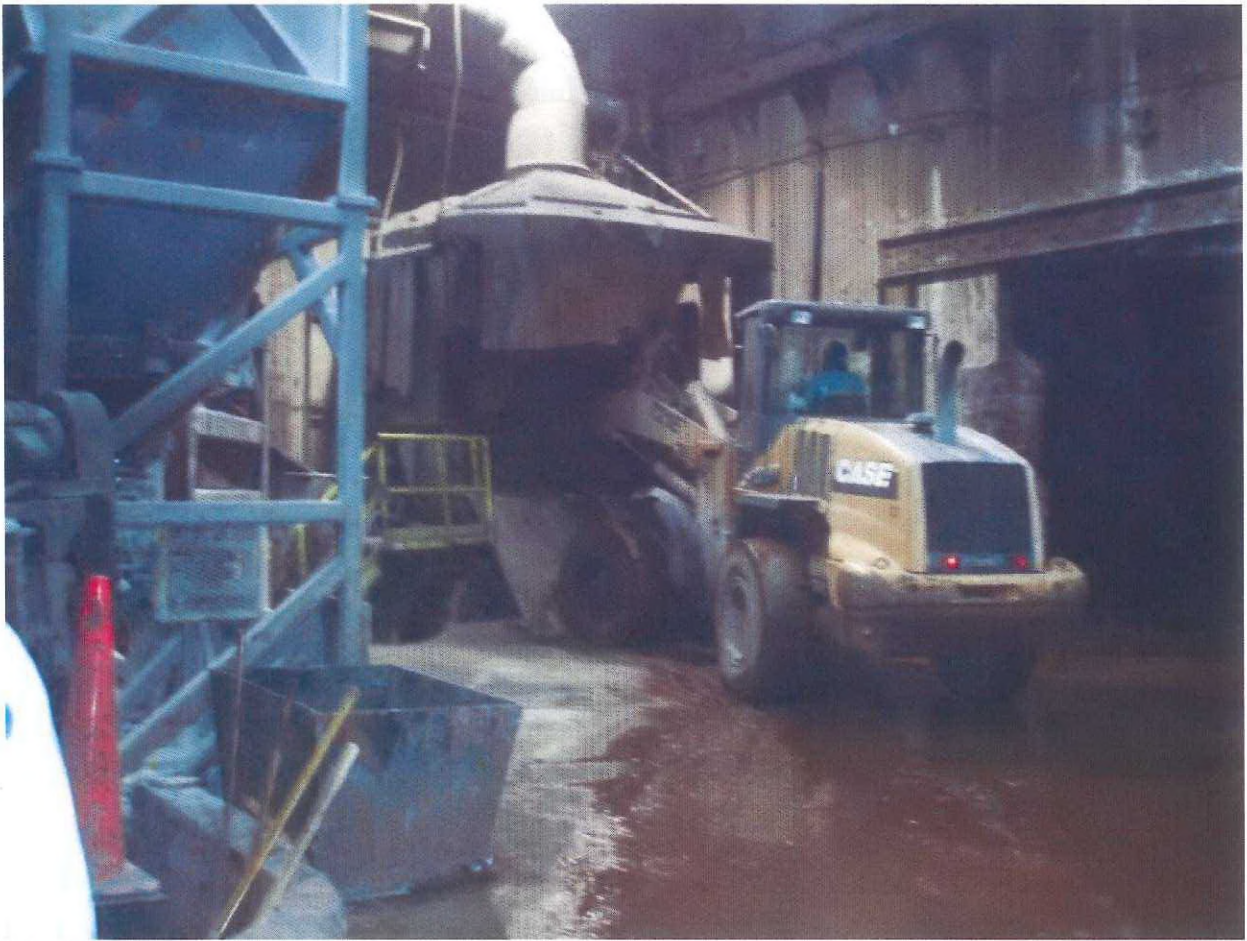
Photograph 28: Drying kiln at the Containment Area at Quemetco, Inc., Indianapolis, Indiana. The digital photograph was collected on May 19, 2009, at approximately 8:42 A.M. (CST). The photographer was Todd Brown, U.S. EPA. The filename is P5190028.

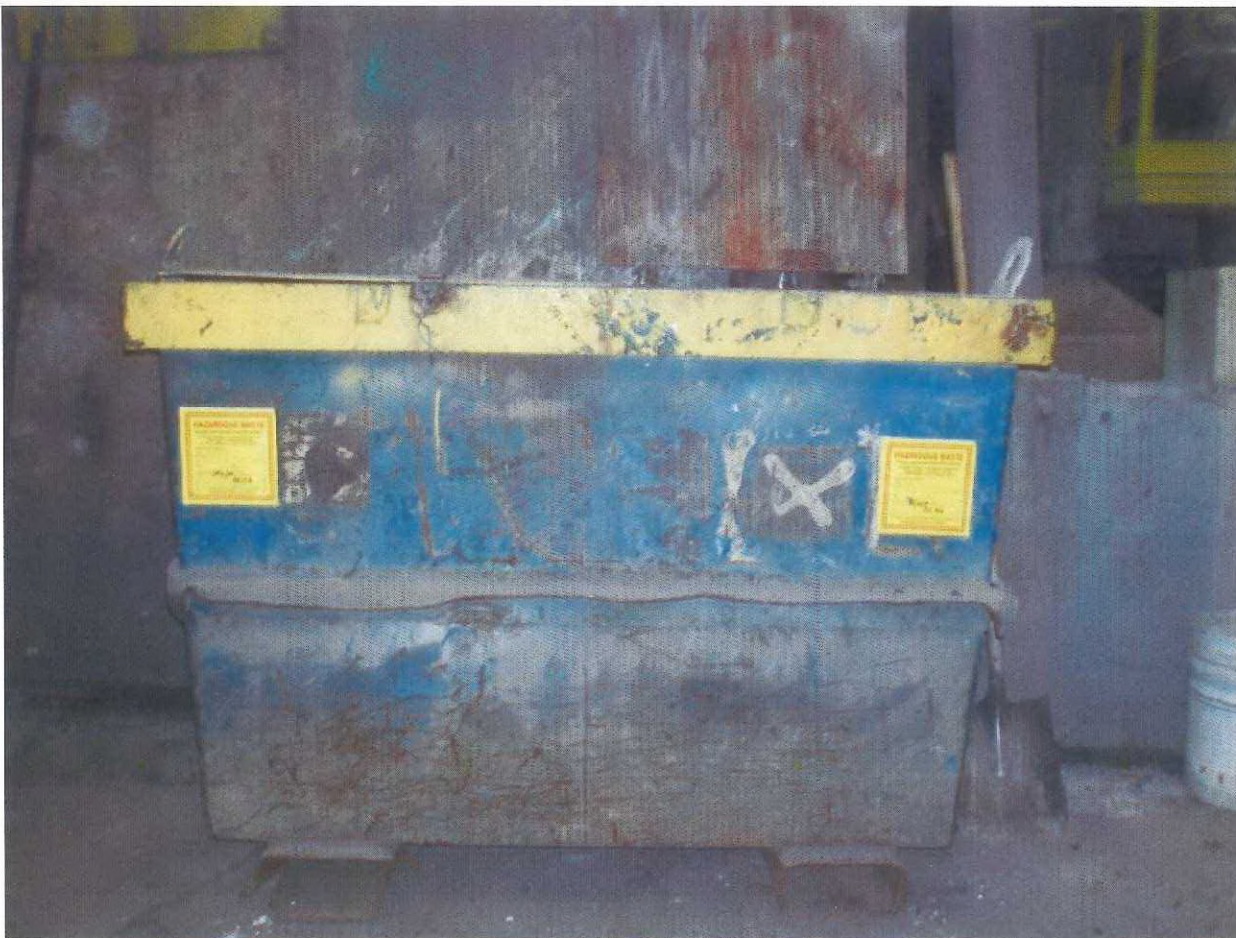
Inspection Item 4: Generators accumulating hazardous waste in a container must keep the lid closed except when it is necessary to add or remove wastes. The facility's Brick/Slag container had the lid open at a time when waste was not being taken from or added to the container.

At the time of the inspection, Quemetco was storing hazardous waste slag and refractory brick in a bisected container, located in the area where its reverboratory and slag reduction furnaces are located. The lid for the section of the container used for collection of slag waste was open, at a time when waste was not being taken from or added to the container. Therefore, Quemetco failed to comply with the above-mentioned generator container storage condition.

Photograph 29: Container for accumulation of refractory brick and slag waste located in the Furnace Room at Quemetco, Inc., Indianapolis, Indiana. The container is separated into two parts for separate collection of the two waste streams. The lid for the right side of the container, used for collection of slag waste, was open at the time of the inspection. The digital photograph was collected on May 19, 2009, at approximately 8:50 A.M. (CST). The photographer was Todd Brown, U.S. EPA. The filename is P5190029.

Response: The Brick/Slag container mentioned in the Notice of Violation is used to hold "hot" pieces of brick or slag as they come out of the two (2) smelting furnaces that are associated with the Quemetco lead reclamation process. Some years ago Quemetco discussed with the IDEM RCRA inspector the issue of the container being closed at all times except when material is being put into it because of the safety hazard that is created if furnace employees have to open the container's lids while handling hot brick or slag. The IDEM inspector agreed to allow the lid to the container to be open but only while the furnace operator was present at his station. Once the furnace operator needed to leave his station, the lid was required to be closed. During the EPA inspection, the furnace operator was present when the lid to the slag portion of the container was observed open. However, this issue of the safety hazard created by requiring the container to be closed was described to the EPA and IDEM representatives during the inspection.

As a result of this inspection, Quemetco has reconsidered its management practice of the slag portion of this container. Up to this point, Quemetco took the more stringent regulatory position and labeled both sides of this split container as hazardous waste when only the brick side contains a waste. The slag from the container is always fed back to the furnace operations to recover the lead content which is how it will be labeled from this point on, as "recycled slag" material. See the attached Standard Work Instructions (SWI) showing the revised procedures with appropriate labeling of this container to reflect this change to this portion of the container. Quemetco requests that the brick portion of this container be allowed to remain open as long as the furnace operator is at his station.

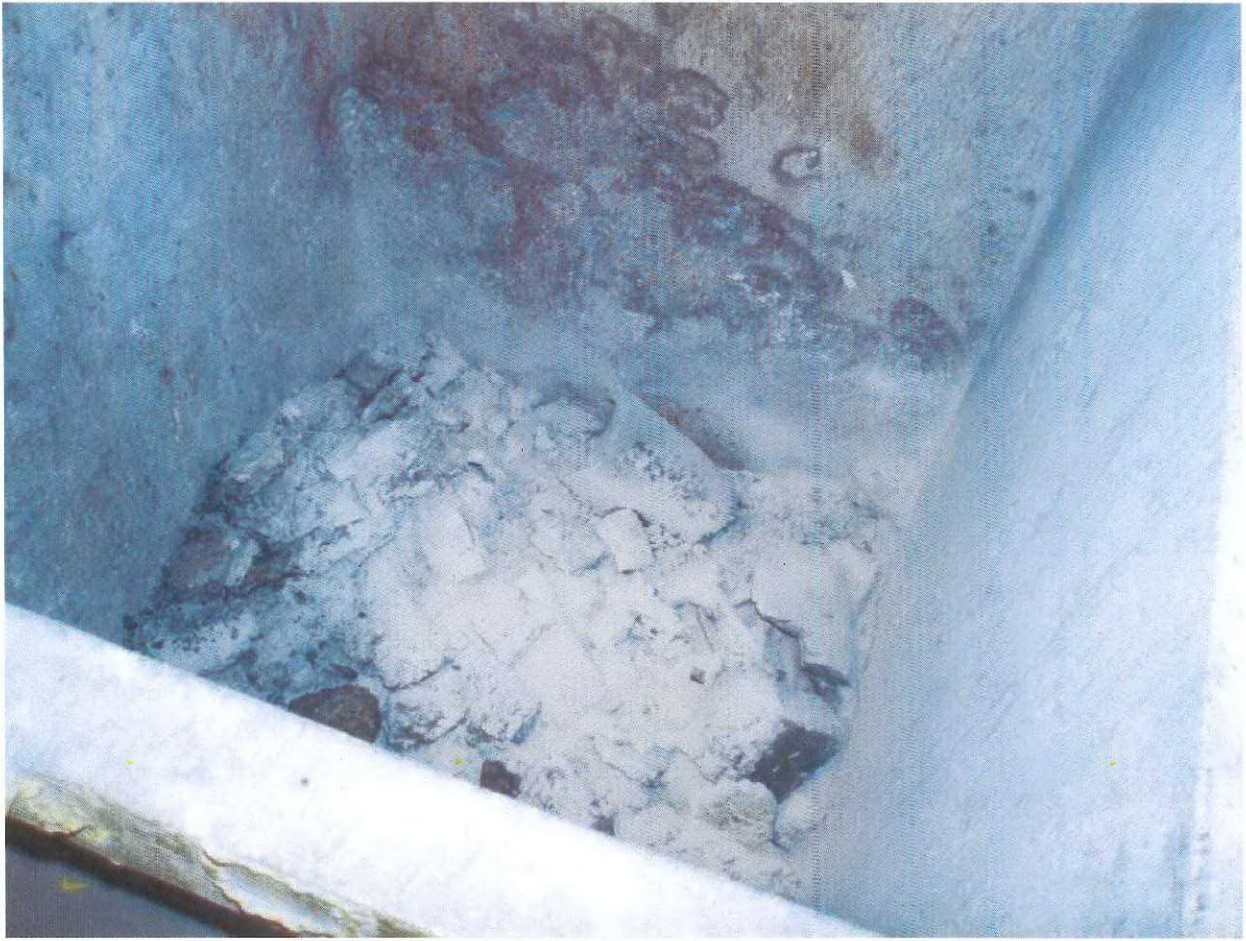
Photograph 30: Slag waste in a container located in the Furnace Room at Quemetco, Inc., Indianapolis, Indiana. This photograph is taken from the top of the right side of the container featured in photograph 29. The lid to this side was open at the time of the inspection. The digital photograph was collected on May 19, 2009, at approximately 8:50 A.M. (CST). The photographer was Todd Brown, U.S. EPA. The filename is P5190030.

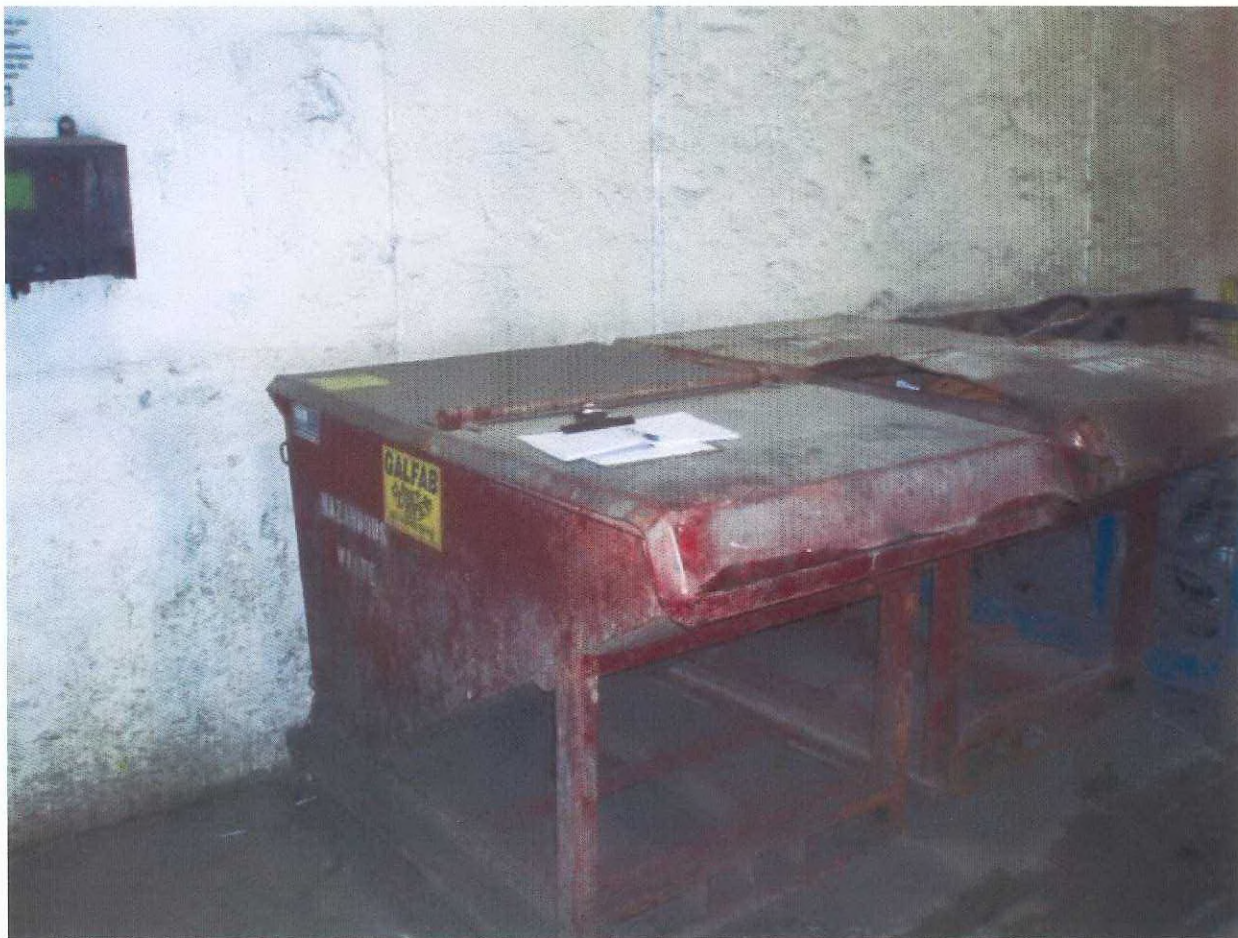
Photograph 31: Container for accumulation of personal protective equipment waste at the Finished Goods Area at Quemetco, Inc., Indianapolis, Indiana (closest container in photograph). The adjacent container contained regular garbage. The digital photograph was collected on May 19, 2009, at approximately 8:56 A.M. (CST). The photographer was Todd Brown, U.S. EPA. The filename is P5190031.

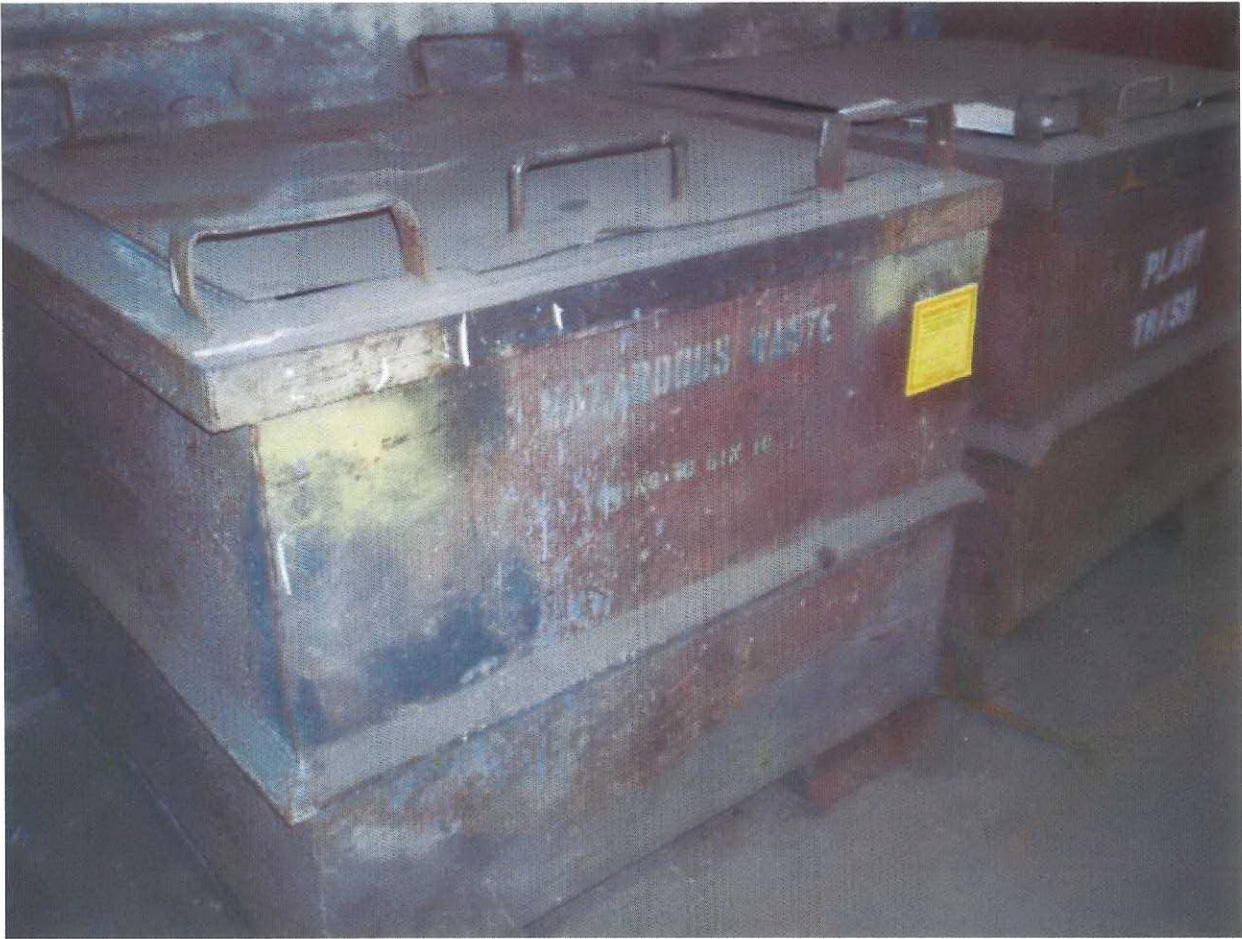
Photograph 32: Container for accumulation of “Lead Trash” at the Finished Goods Area at Quemetco, Inc., Indianapolis, Indiana (closest container in photograph). The digital photograph was collected on May 19, 2009, at approximately 9:00 A.M. (CST). The photographer was Todd Brown, U.S. EPA. The filename is P5190032.

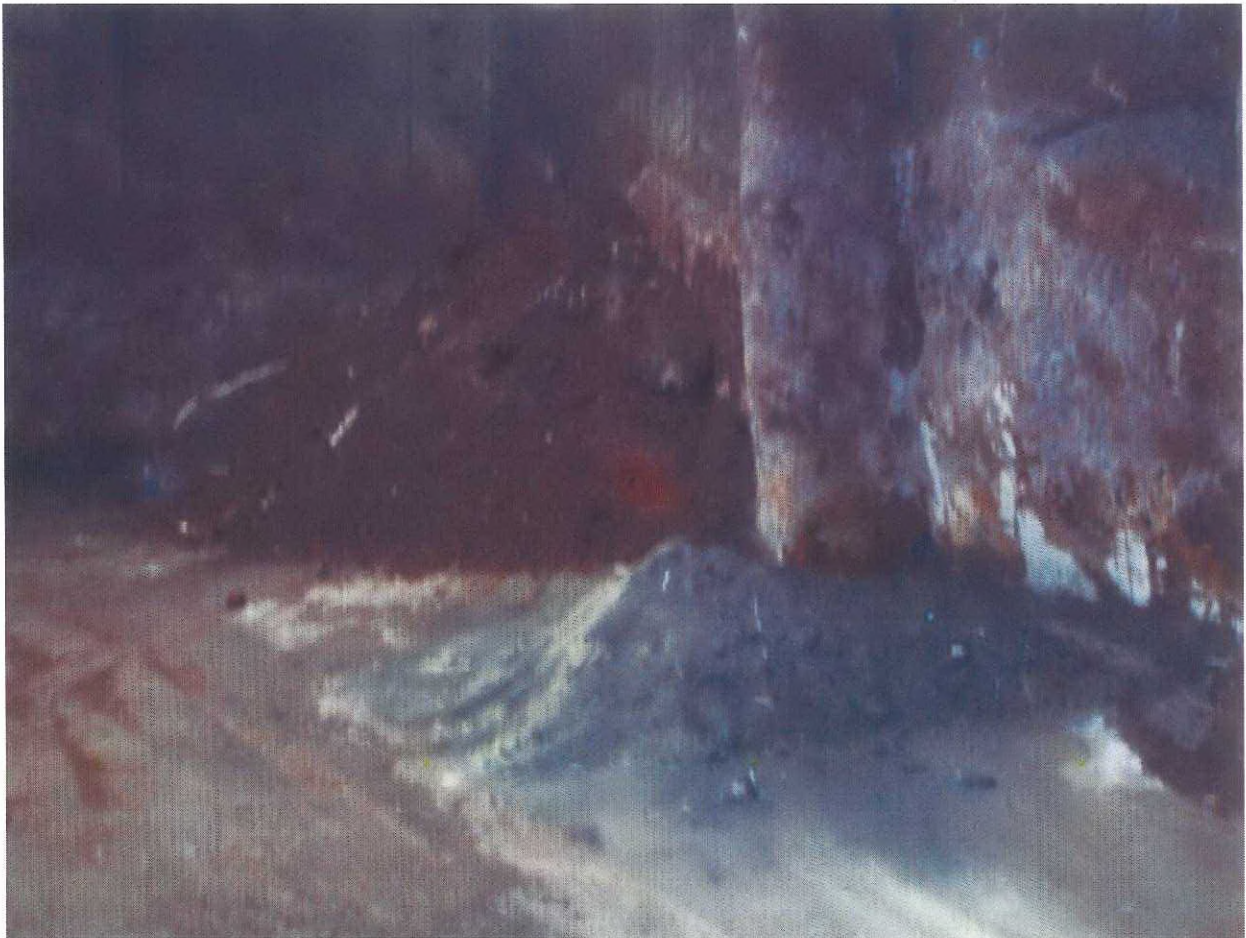
Photograph 33: Piles of ground lead oxide paste and metallic battery components, and dross in the Bin Room at Quemetco, Inc., Indianapolis, Indiana. The brown pile is ground lead oxide paste/metal; the gray pile is dross. The digital photograph was collected on May 19, 2009, at approximately 9:06 A.M. (CST). The photographer was Todd Brown, U.S. EPA. The filename is P5190033.

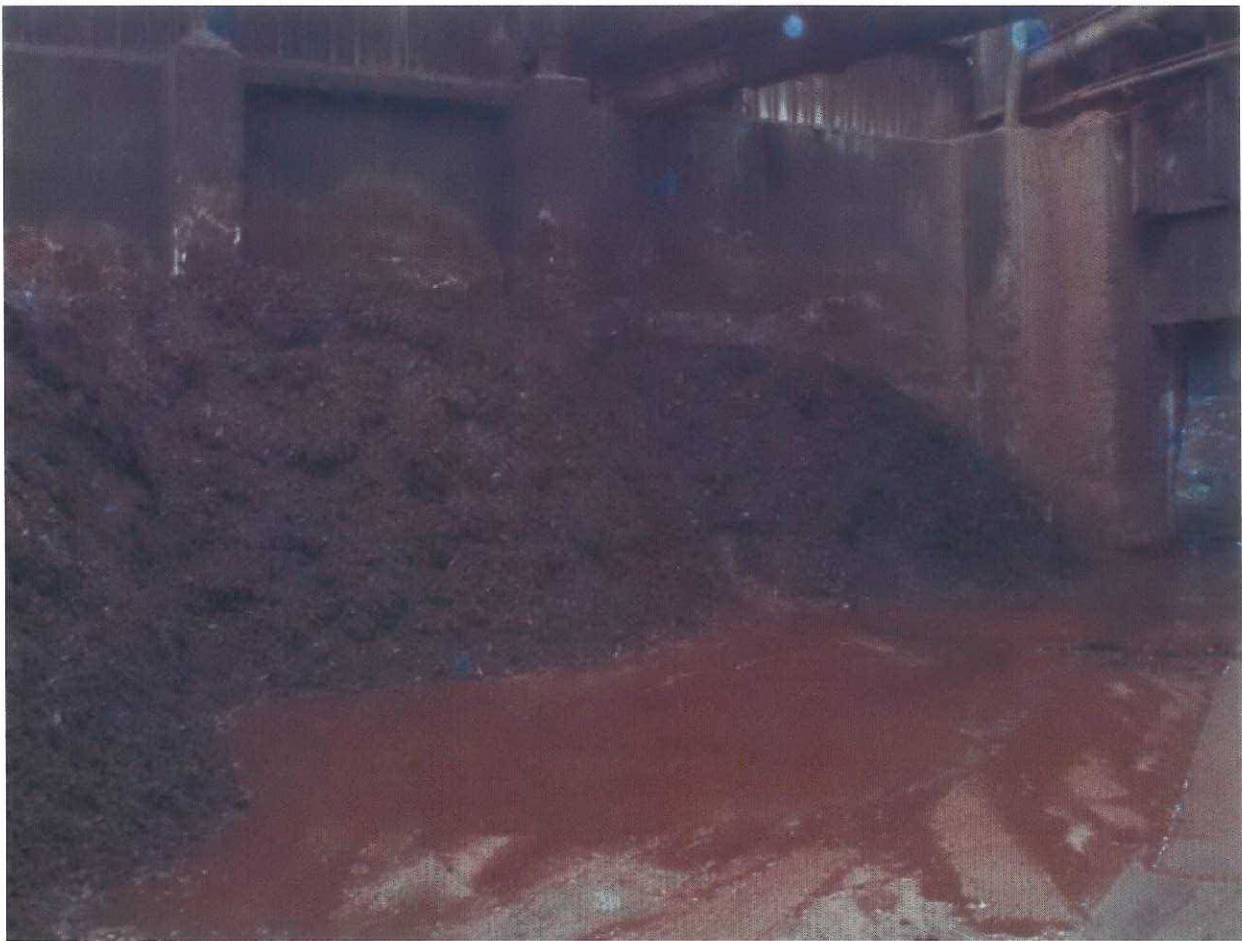
Photograph 34: Pile of ground lead oxide paste and metallic battery components in the Bin Room at Quemetco, Inc., Indianapolis, Indiana. The digital photograph was collected on May 19, 2009, at approximately 9:06 A.M. (CST). The photographer was Todd Brown, U.S. EPA. The filename is P5190034.

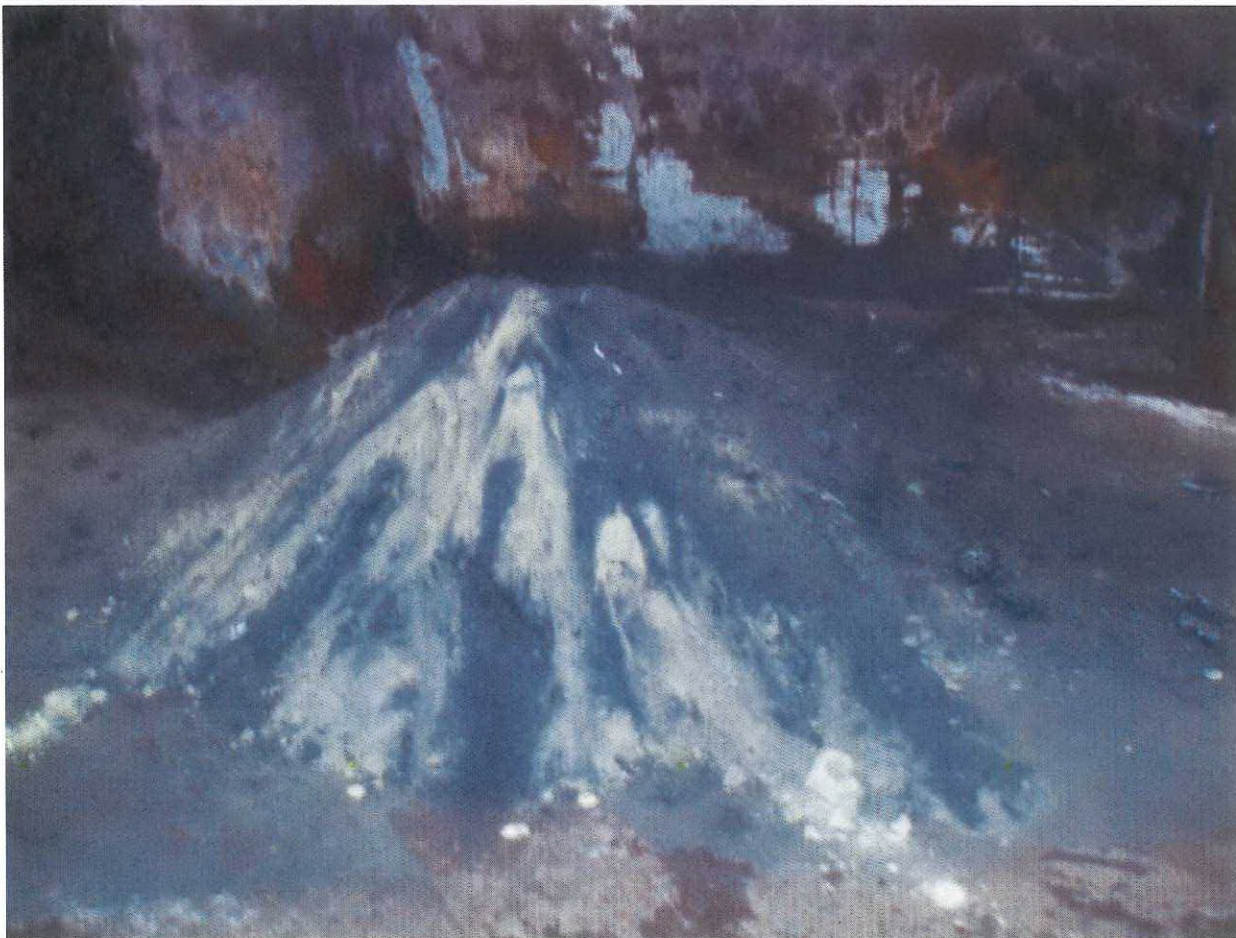
Photograph 36: Pile of dross in the Bin Room at Quemetco, Inc., Indianapolis, Indiana. The digital photograph was collected on May 19, 2009, at approximately 9:08 A.M. (CST). The photographer was Todd Brown, U.S. EPA. The filename is P5190036.

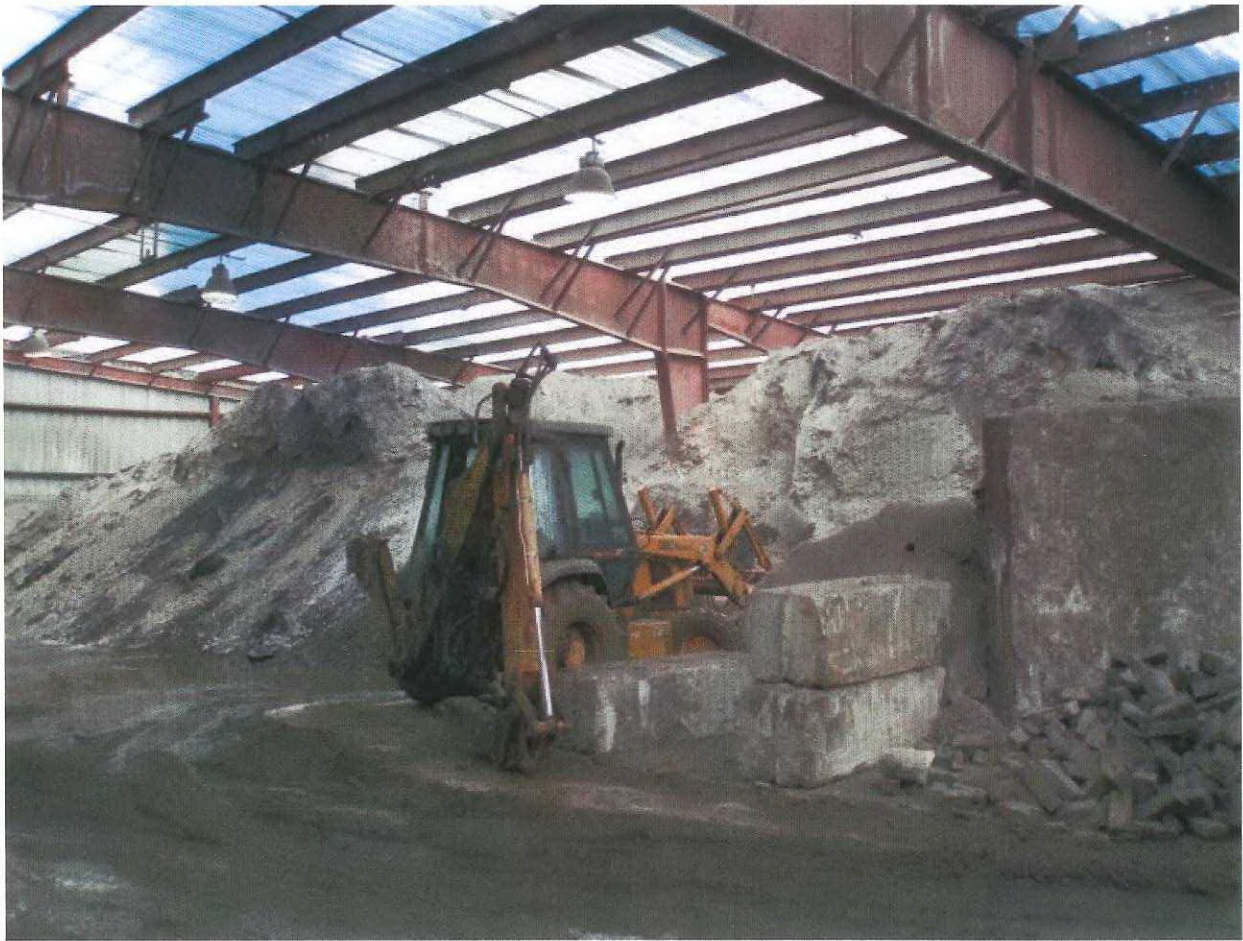
Photograph 37: Piles of slag in the Slag Warehouse at Quemetco, Inc., Indianapolis, Indiana. The digital photograph was collected on May 19, 2009, at approximately 9:11 A.M. (CST). The photographer was Todd Brown, U.S. EPA. The filename is P5190037.
